*Report on the Condition of*

**CHRIST CHURCH, SWINDON, WILTS  
(Bristol Diocese)**

prepared for **Christ Church with St Mary's PCC**

July 2022

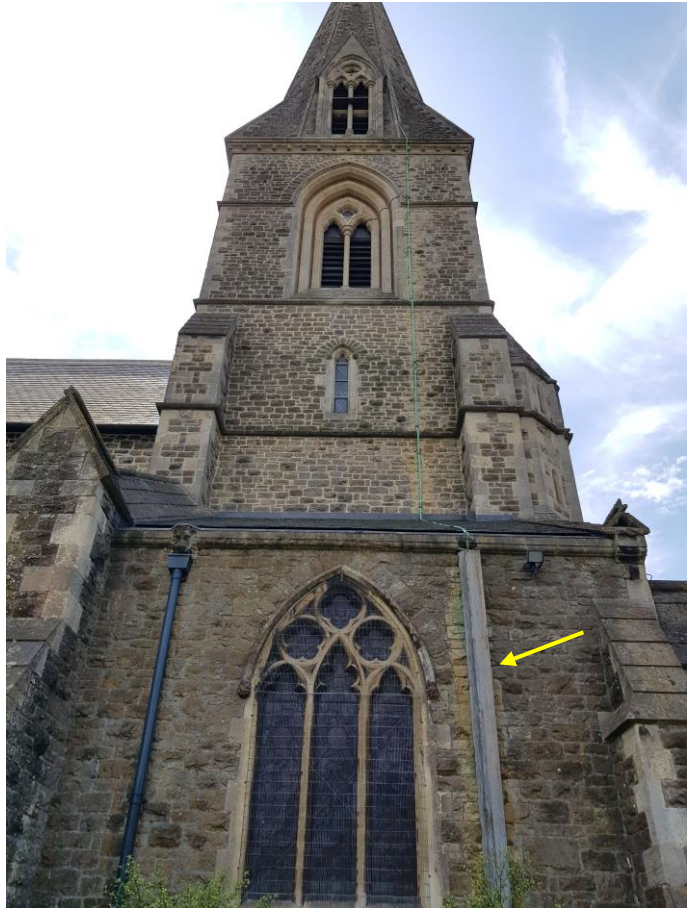
*Figure 5* View of the tower north side showing timber casing to the lightning conductor tape; presumably required for insurance purposes. The casing is unsightly and, at the very least, would benefit from redecoration

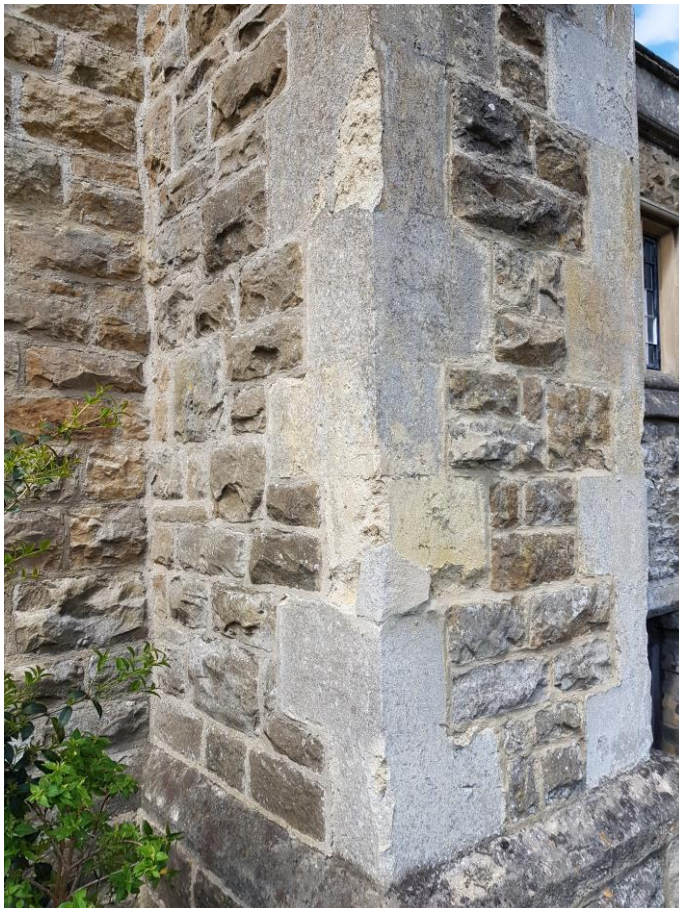
*Figure 6* Detailed view of the buttress to the north-east corner of the chancel, which shows ‘soft bed’ erosion and surface decay to the stonework, typical examples of decay to ashlarwork found throughout the church externally

- xii) Carry out programme of conservative repairs to decaying ashlar/dressed stonework.
- xiii) Overhaul/repair churchyard pathways where required.
- xiv) Commission energy/sustainability audit for the church, possibly including ancillary buildings. Implement recommendations of the report.
- xv) Review need for provision of stone guards to decorative glazing and renew where necessary.

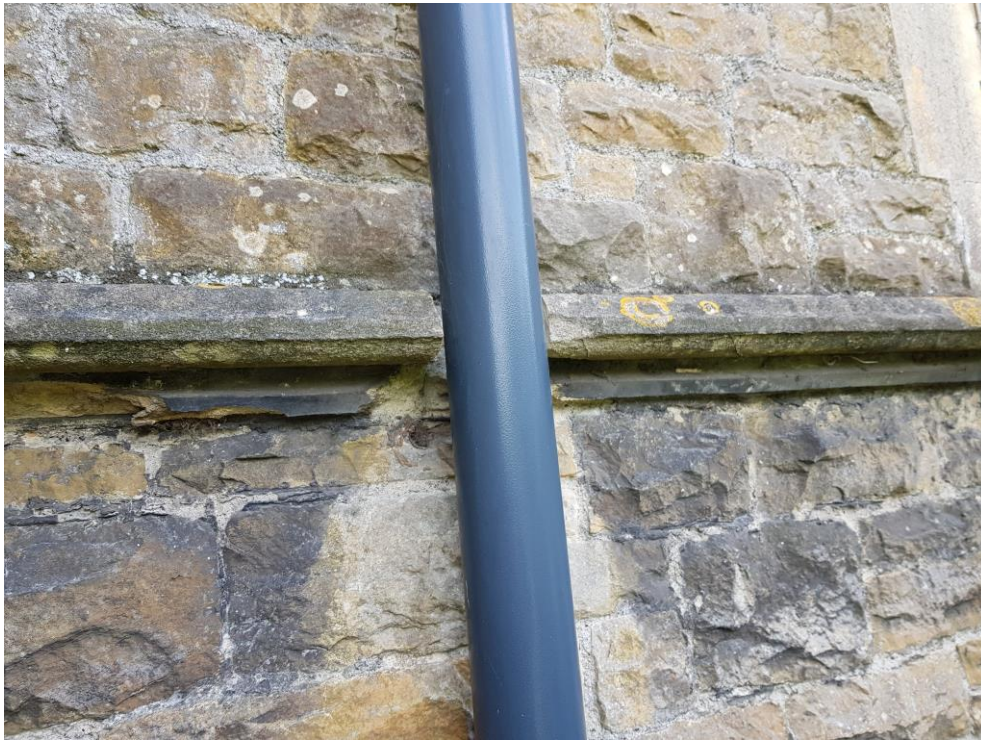
*Figure 7* Example of where a string course has been cut through to allow fitting of rainwater goods, presumably carved out as part of the recent overhaul of the chancel roof carpentry and rainwater disposal system

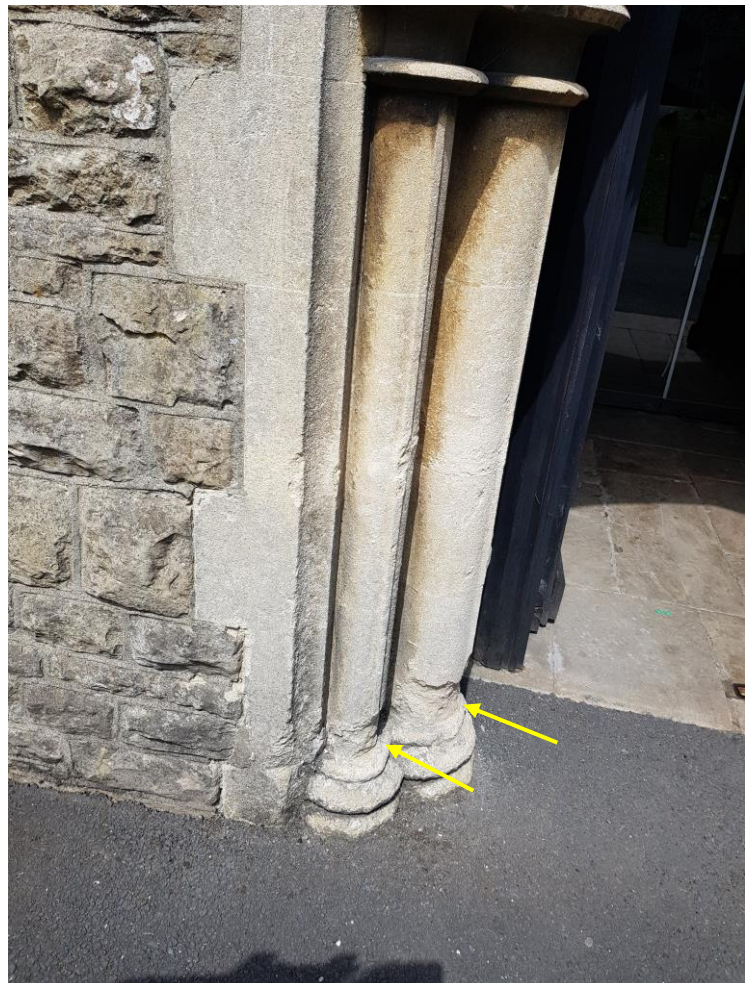
- v) *Doors:* slight rusting to the external ironwork of the door of the boiler house; slight decay to the boards at the foot of the same door; advanced soft bed erosion to eastern jamb of the south porch door; soft bed erosion also to the base and shafts of the lower sections of the columns of the same door; very slight surface decay to the hood mould above the south porch door

*Figure 8* View of left-hand jamb of the south porch door opening showing advancing decay to the column bases; repairs to this type of defect should be carried out soon to stave off further decay

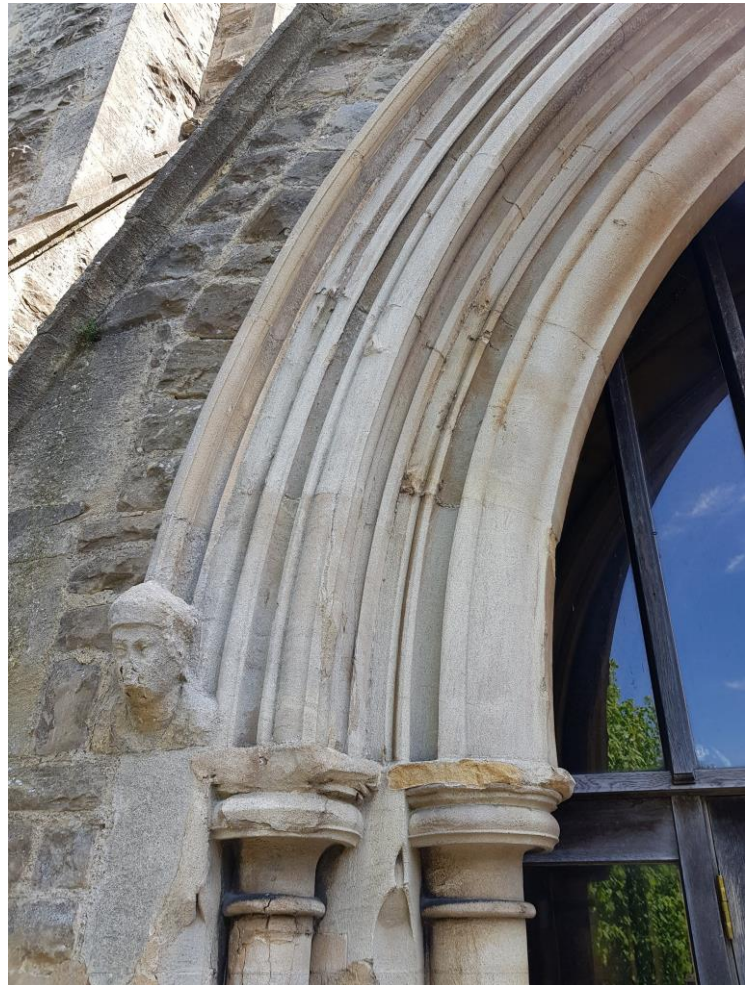
*Figure 9* View of the left-hand springing point to the external arch of the west door showing extensive decay to dressed and carved limestone ashlarwork, together with previous mortar repairs now succumbing to decay; these repairs were originally intended as sacrificial to protect the stonework to which they were applied). Renewal of mortar repairs and other conservative repairs to external stonework would be of considerable benefit to conserve the church fabric within the next quinquennium

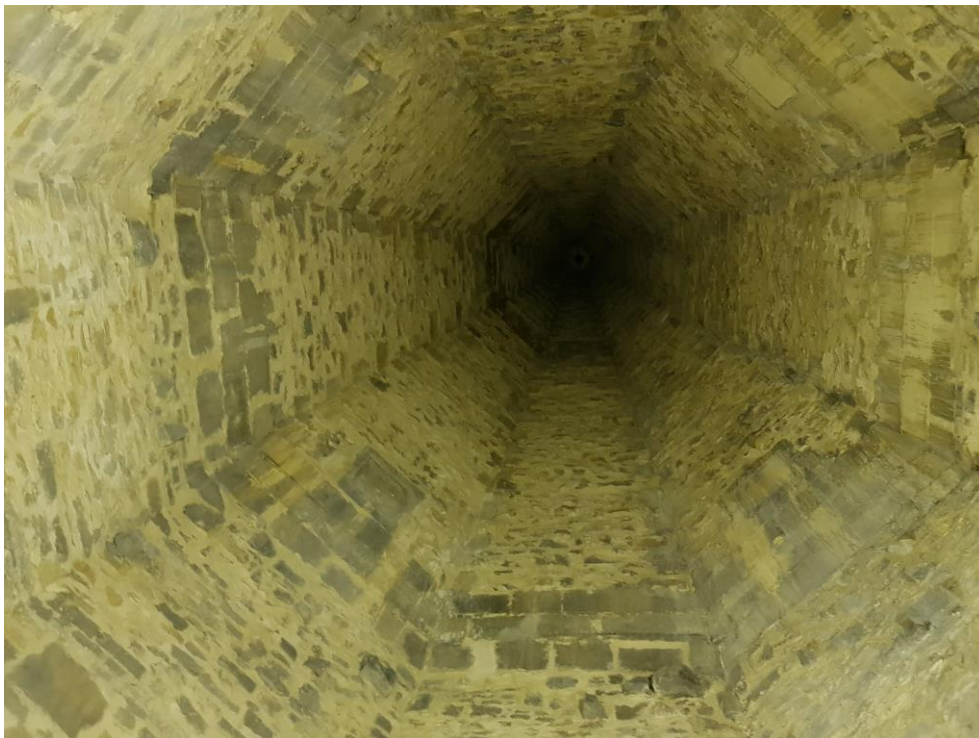
*Figure 10* General view of the underside/interior of the spire as viewed from the deck at the base; the spire interior was dry at the time of inspection, however it was reported by the churchwarden that water ingress through the spire masonry remains an issue

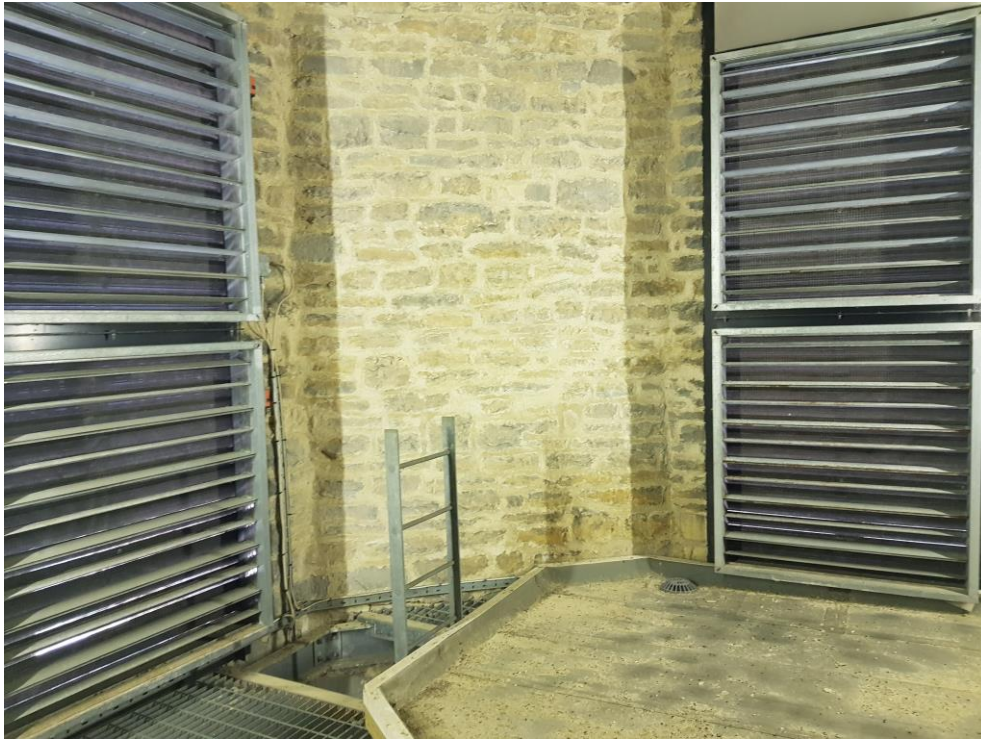
with bird mesh (10mm sq) and fine insect mesh (2mm sq). According to the churchwarden, the baffles were introduced to prevent rainwater ingress into the tower via the belfry openings, but it was later discovered that the main means of water ingress was through the spire masonry, not through the belfry openings. Inspection of the belfry openings and their louvres was not possible due to the internal baffles being in the way; some of the baffle blades are beginning to corrode, particularly at lower level to the west and south sides – this appears to have advanced slightly since the previous report was carried out in 2014.

*Figure 11* General view of the spire interior showing the main-deck and internal, electronically-operated baffles fitted to each of the tower belfry openings

- i) Consider cleaning of sample area of water/salts-stained internal masonry, with a view to carrying out localised cleaning in the future.
- ii) Repair holes/gaps in internal masonry left following removal of previous services fixings.
- iii) Provide new suitably-designed podium to the lectern.
- iv) Consider removal / renewal of floor covering in the vestry.
- v) Review the need for/purpose of mechanical baffles to the belfry openings.

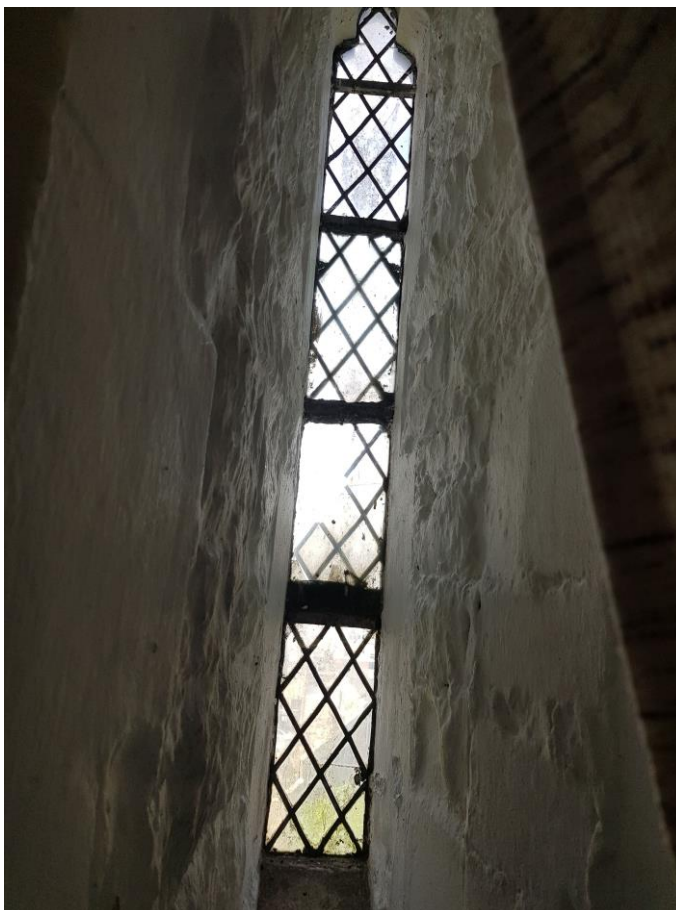
- iii) *Windows*: two lancet windows on the west wall; damaged leadwork comes to the northern window, glazed over internally; one cracked quarry in the upper and lower panes of the same window; two cracked quarries in the upper section of the south window in the west wall; one broken quarry in the second section from the top of the same window; internal over-glazing to the second panel from the bottom to the south window in the west wall; quarries in the lower panel of this window undulate slightly; lancet window in the north wall with one dislodged quarry in the opening section.

*Figure 13* View of north lancet window in the west wall of the ringing chamber, currently in need of repair

- i) Carry out repairs to broken lancet windows in the west wall of the tower.
- ii) Carry out repairs to the western boundary walls of the church.
- iii) Carry out repairs to cracked lintels of ventilation opening in the boiler-house, replace rusting ventilation louvres with corrosion-resistant items.
- iv) Clean, treat and re-decorate rusting window ferramenta and door ironmongery.
- v) Review results of previous/ongoing structural monitoring carried out to areas of structural movement in the church, ascertain whether further monitoring/repairs are required.

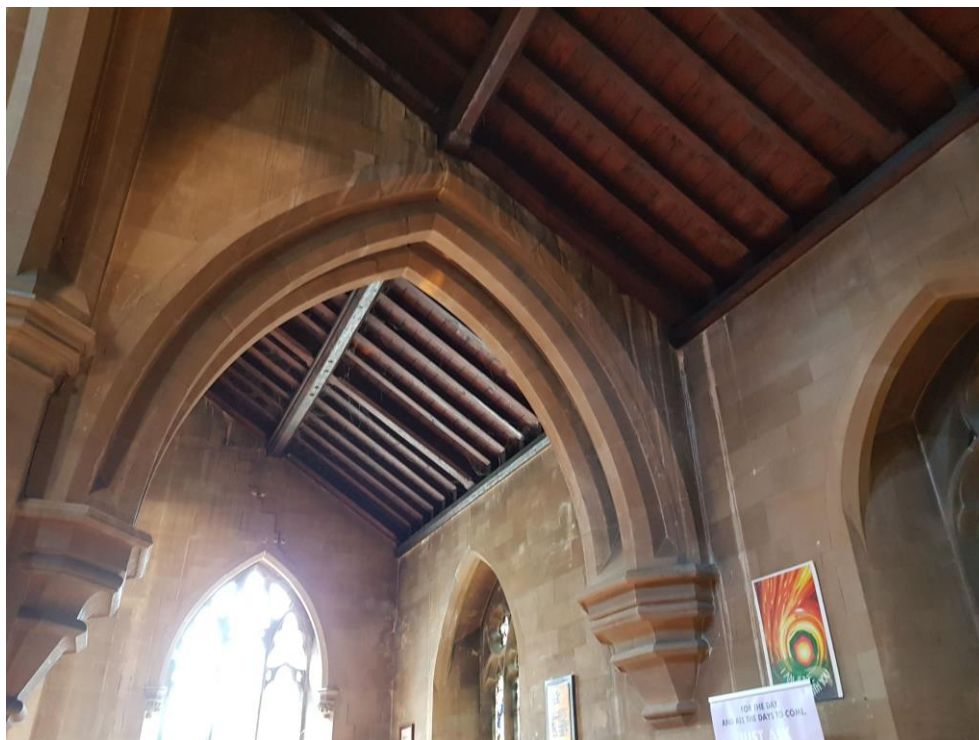
- i) *Ceiling:* Exposed dark-stained roof structure, as the nave. No defects were noted.
- ii) *Walls:* water staining above the west window, probably caused by previous water ingress since rectified by the recent re-roofing work; slight stepped cracking running from the head of the west window in the north aisle towards the roof and downwards from the springing point of the northern jamb of the same window towards the junction with the north wall; similar stepped cracking running from the junction of the cill and the right-hand jamb of the same window towards the junction of the west and north wall at low level; extensive damage to stonework below the west window of the north aisle, possibly due to recent installation of the heating system; very slight opening of vertical joints in stonework above the west window in the north wall of the north aisle; very slight frassy decay to the surface of the stonework of the north wall towards the west end at high level; signs of previous water staining along the north wall generally, probably caused by previous water ingress which has since been rectified by the recent re-roofing work; very slight opening of vertical joints above the east window in the north aisle.

*Figure 15* General view at the west end of the north aisle interior showing staining to stonework from previous ingress through the roof, presumably prior to renewal of the roof coverings

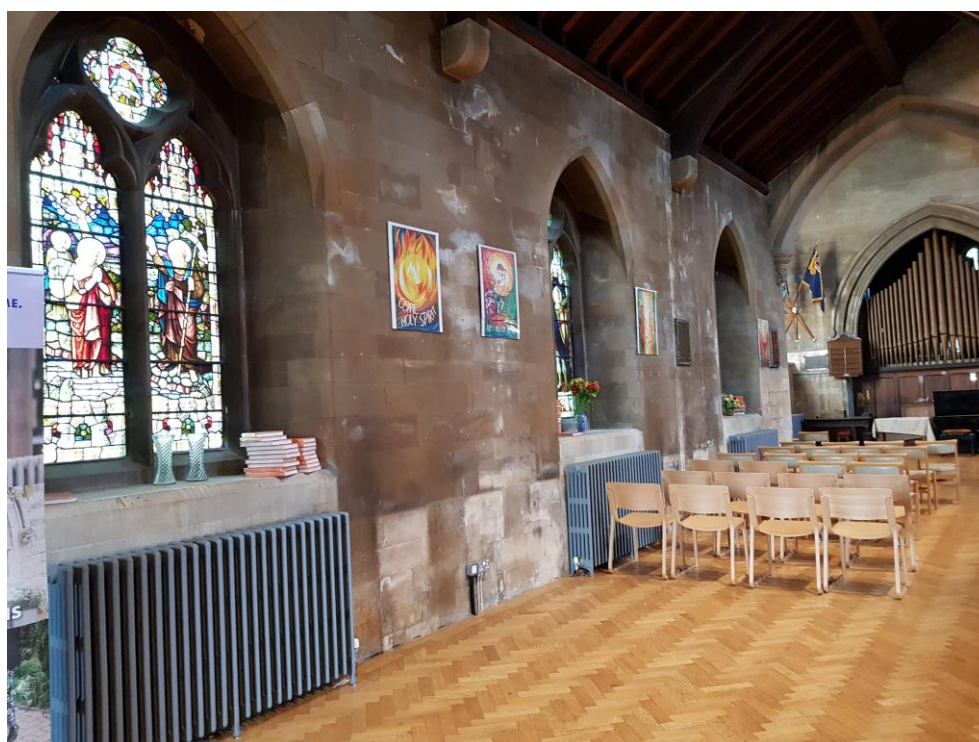
*Figure 16* General view of the north wall of the north aisle showing salts related staining and ghost-marks where previously fitted pews have been removed

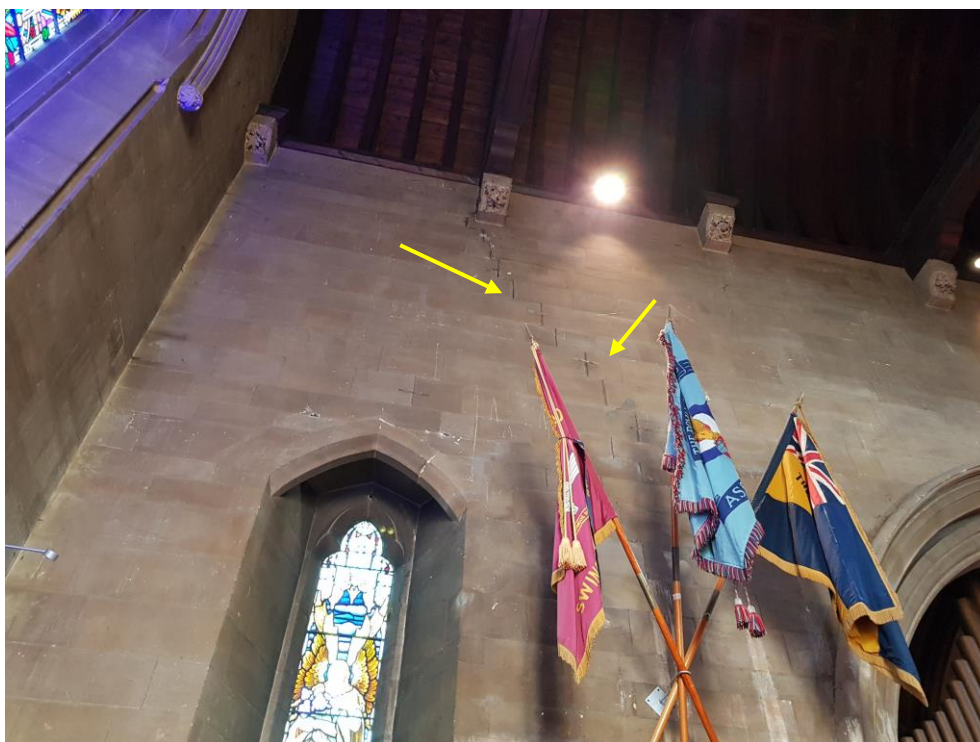
*Figure 17* 'Stepped' cracking to ashlar masonry at high level to the east wall of the north transept

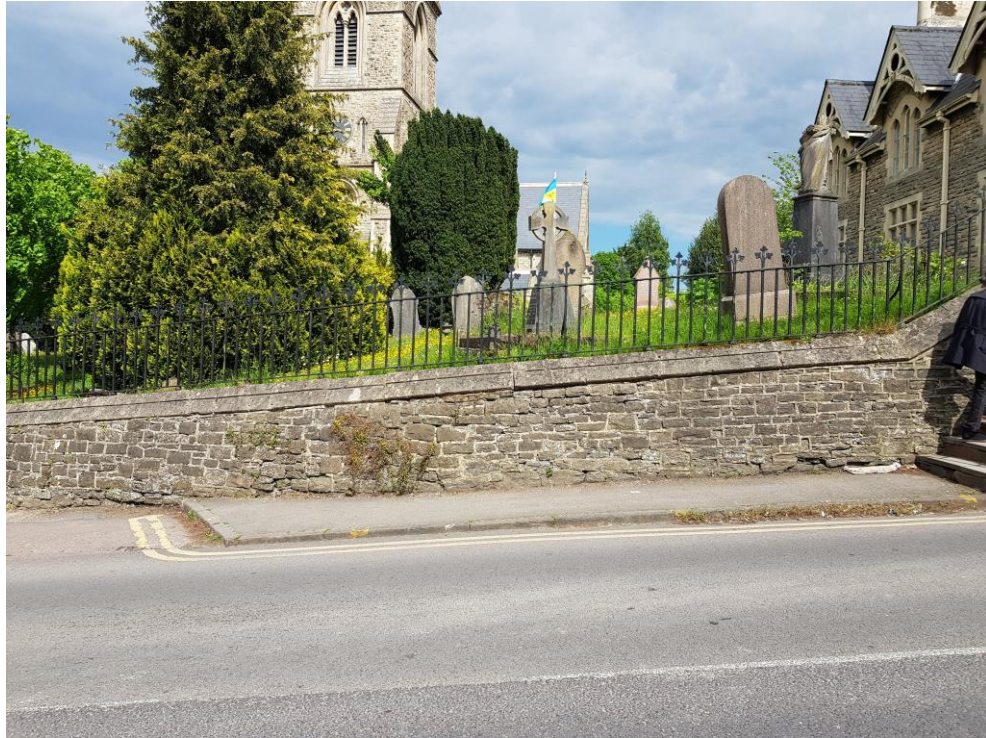
The external carved/ashlar work is beginning to show signs of its age, and would now benefit from minor repairs/consolidation in order to slow down the rate of decay. Repairs to the west boundary wall have been called for in previous inspection reports and we recommend this work should now be undertaken.

*Figure 19* General view of the church and the west boundary wall from the public highway; this boundary wall has a number of missing/loose stones and the pointing/bedding to the rubblework is generally in poor condition. Repairs to the wall would be prudent within the next quinquennium

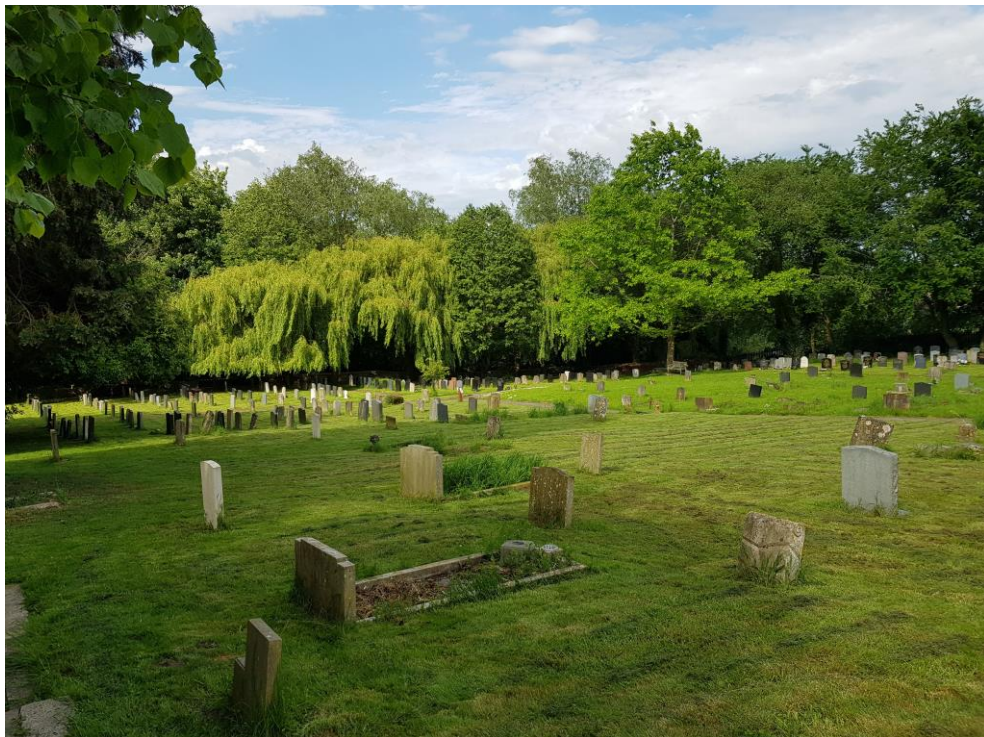
- viii) *Grave markers*: vast number of headstones and monuments within the churchyard, ranging in date from the late 19<sup>th</sup> c up to the present day. A number of the churchyard monuments were noted to be leaning, and upon limited

inspection (due to the time constraints allowed for the survey), some were found to be unsteady. The PCC should continue to carry out assessments of churchyard monuments and carry out repairs as necessary.

*Figure 20* General view of north eastern section of the churchyard. This large area is well maintained and its pathways, trees, boundaries and grave markers should be kept under continual review to ensure the safety of the many visitors.

- i) Fold down and fix as necessary the wind-lifted cover flashings at the junction of the tower and north aisle roofs, or consider fitting heavier-gauge lead.
- ii) Assess headstones/grave markers for stability/safety, carry out repairs, propping, stabilisation or other safety measures as necessary.
