Report on the Condition of

**ST MARY'S, COMMONWEAL ROAD, SWINDON, WILTS
(Bristol Diocese)**

prepared for **Christ Church with St Mary's PCC**

August 2022

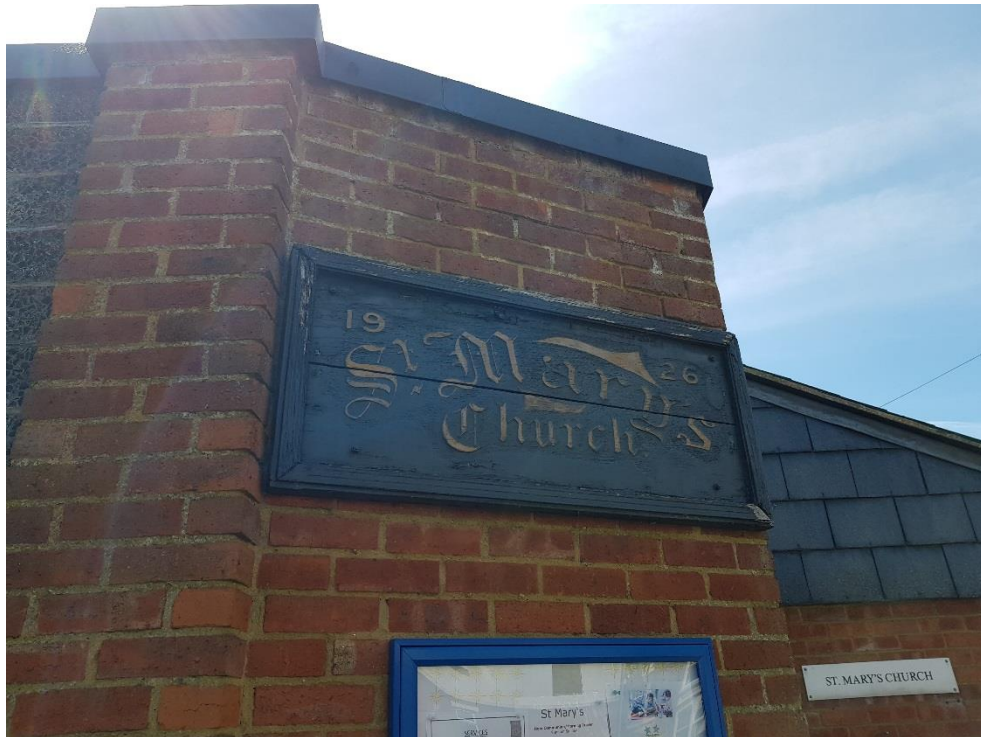
Figure 3 Signboard from St Mary's Church, 1926, which originally stood on the site. The signboard is mounted on the north wall of the church.

- ii) In conjunction with item 8.03 (iii) above, consider provision of a hearing loop and / or improvements to the WC to comply with Building Regulations.
- iii) Consider conservation/redecoration of the 1926 signboard.

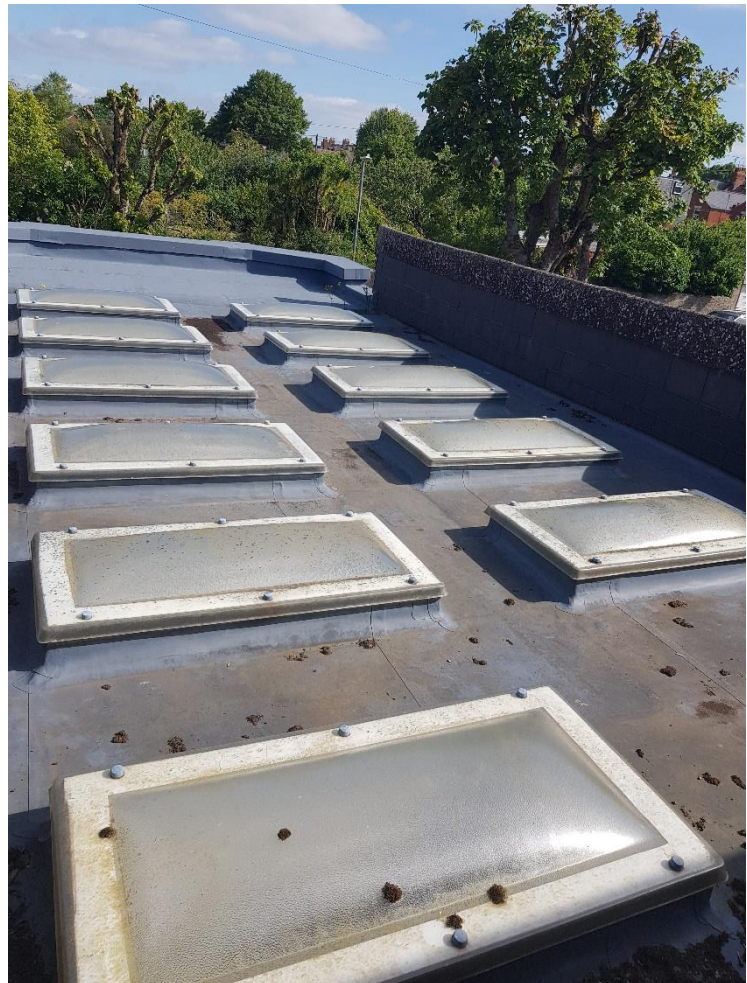
Figure 6 General view of the nave roof facing north towards the chancel. This roof is covered with a proprietary single-ply membrane and appears to have been renewed relatively recently.

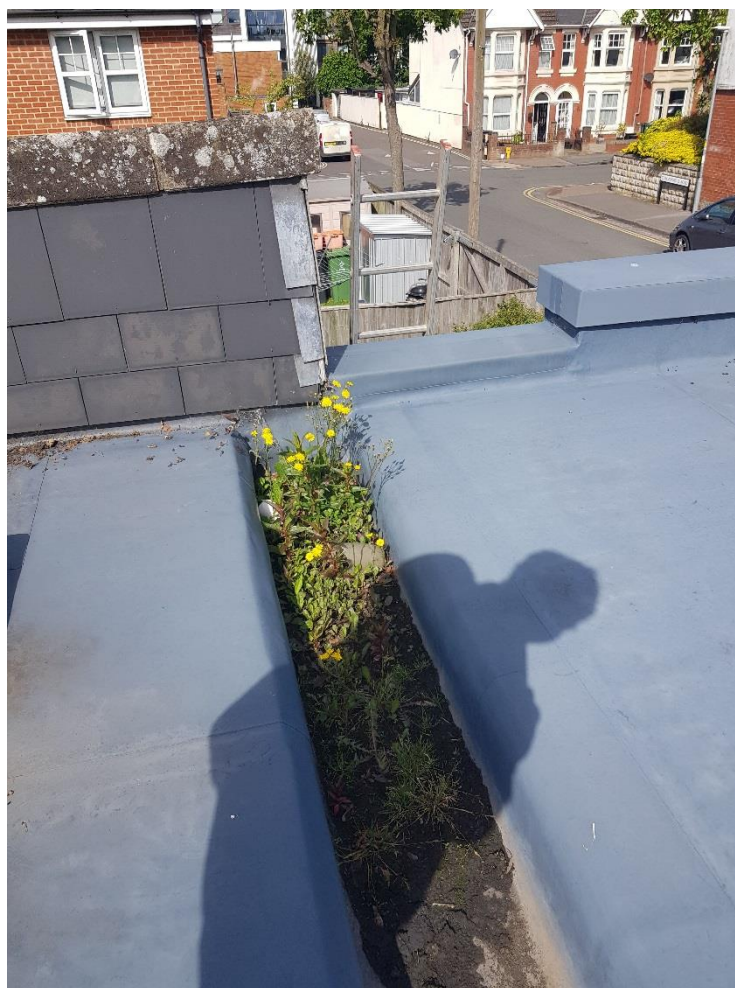
Figure 7 General view showing sump/gutter forming junction between the roofs of the nave and the chancel. A build-up of vegetation/detritus was blocking the rainwater outlet here, which was cleared during the inspection. This area should be frequently checked for blockages.

- i) Check rooftop gutters/outlets on a regular (at least annual) basis, clear if required.
- ii) Make safe/repair broken/cracked glass blocks to openings in the chancel.
- iii) Remove stored items from the pathway to the west of the church.

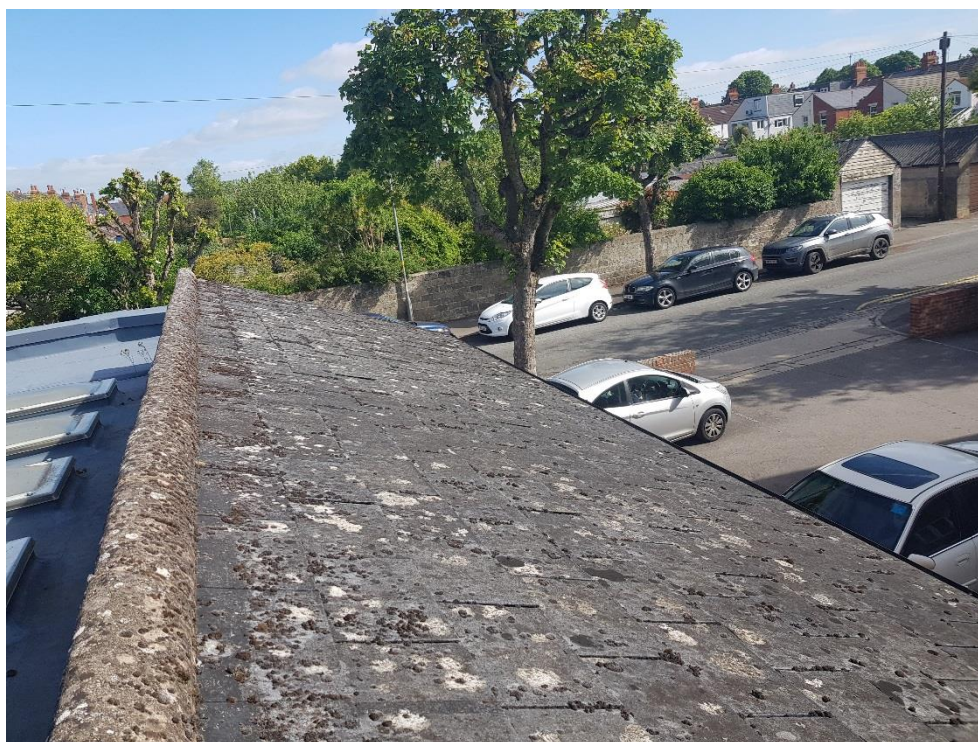
Figure 8 General view of the east aisle roof covered with artificial fibre (possibly asbestos-containing) reinforced cement slate. If not already carried out, an asbestos survey should be completed before carrying out works likely to disturb this roof.

As noted in previous reports, there are elements of the building fabric (fibre cement slates; internal 'stippled' plasterwork) which may contain asbestos. If not already carried out, a survey of deleterious materials should be carried out and recommendations for management of such materials, especially if building works are carried out, should be followed.

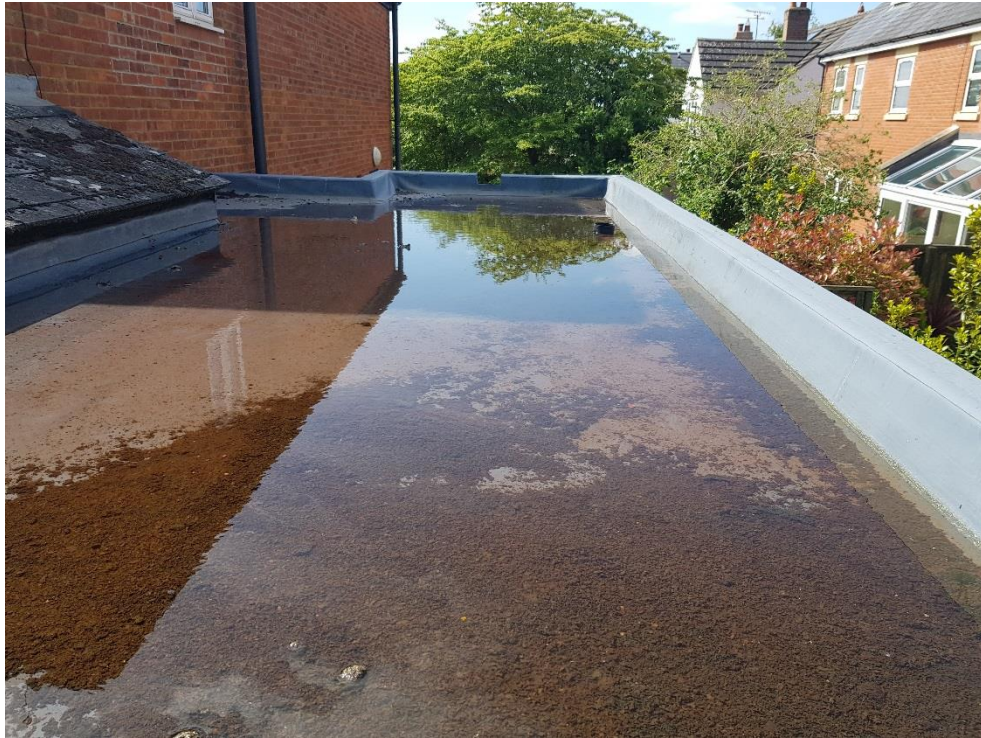
Figure 9 General view across the flat roof. The rainwater outlet was blocked causing ponding of water on the roof, which was cleared during the inspection

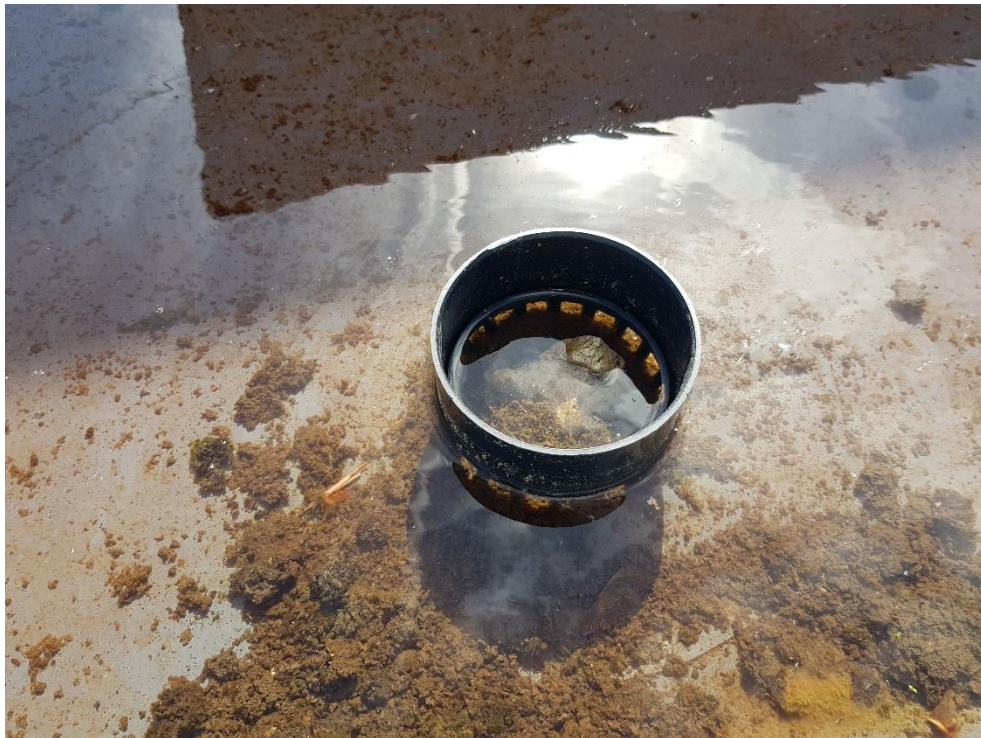
Figure 10 Blocked outlet to the flat roof above the entrance hall/toilet, this outlet should be checked/cleared regularly.

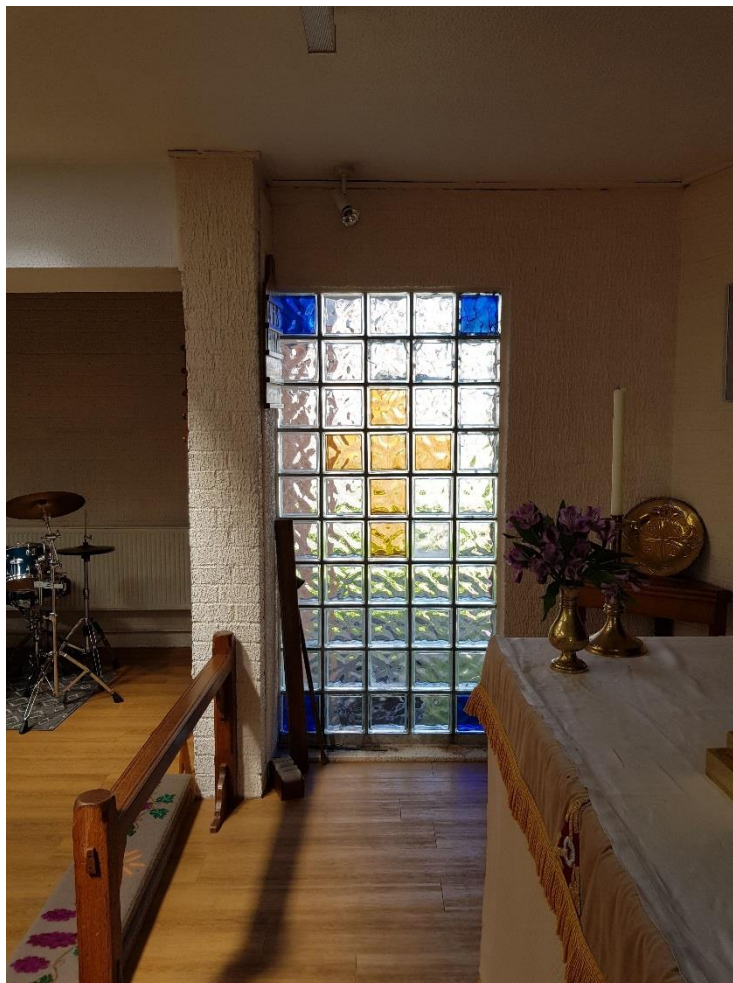
- ii) *Windows:* glass block lights to the east and west walls of the chancel. A number of the blocks are broken internally – see 6.01 (ii); single glazed, extruded aluminium casements to the west elevation, WC and the south elevation of the entrance hall are now of some age but appear to be functional.
- iii) *Doors:* Main entrance doors are formed of varnished hardwood with Georgian-wired glazing; escape door from the kitchen/social area formed of painted timber with Georgian-wired glazing, door leaf appears to have been redecorated recently but not the timber threshold.
- iv) *Noticeboard:* low-relief-carved and painted timber signboard from the original church on the site (1926); generally in good condition however the paintwork is faded and is flaking around the border.

Figure 14 View of the west-facing glazed light in the chancel wall, which has a number of cracked and broken glass blocks. These are dangerous and measures to make the glazing safe should be put in place immediately

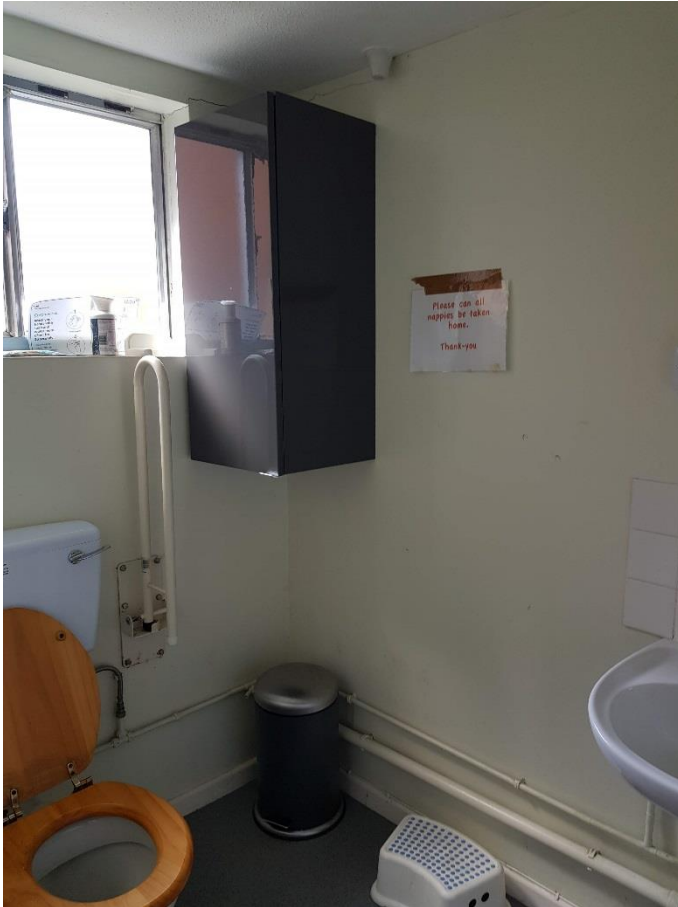
- i) *Walls:* formed in painted plaster. Defects noted as follows: horizontal cracking at the junction of the east and west walls with the ceiling, running towards the head of the window in the south wall; slight breaking down of the decoration around the pipework in the north-west corner; damage to the plasterwork behind the radiator on the north wall; decoration is generally worn/tired.
- ii) *Floor:* finished with in non-slip vinyl/linoleum, generally in good condition.
- iii) *Ceiling:* textured plasterwork with painted finish, as elsewhere in the church.

Figure 15 General view of the bathroom showing horizontal cracking at the junction of the ceiling and walls, presumably due to slight differential movement between the masonry and the timber wallplate behind the plaster finish.

- i) Fill cracks in the masonry above the bathroom window internally and monitor; consider redecoration of the bathroom.
- ii) Carry out a Fire Risk Assessment for the building (if this has not been carried out already); implement the recommendations of the report.
- iii) Commission inspection/test/report on presence of asbestos/other deleterious materials, if this has not already been carried out; enact the recommendations of the report.
- iv) Arrange for electrical installation to be checked/tested/inspected following NICIEC format; carry out urgent recommendations of the report on the electrical installation.
- v) Consider re-locating the central heating controls.
- vi) Arrange for boiler and flue to be checked/serviced on an annual basis.

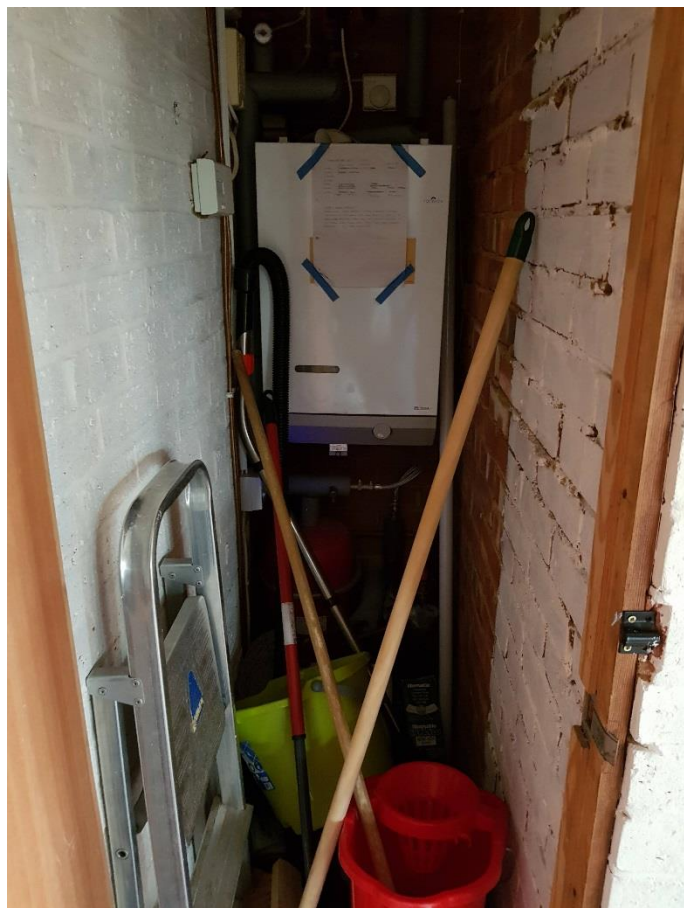
cupboard in the south-west corner; gas meter at low level in the same location; gas combination boiler mounted in the cleaner's cupboard in the south-west corner of the entrance lobby, with a programmable thermostatic timer control mounted on the wall; the positioning of the thermostatic control coupled with cleaning equipment being stored in front of it makes access to it difficult.

Figure 16 View into the janitor's cupboard within which the central heating boiler and heating controls are located. Access to the heating controls is difficult when the cupboard is full.
